NASA Conference Publication 2190

Aircraft Engine Diagnostics

*A conference held at
Lewis Research Center
Cleveland, Ohio
May 6-7, 1981*

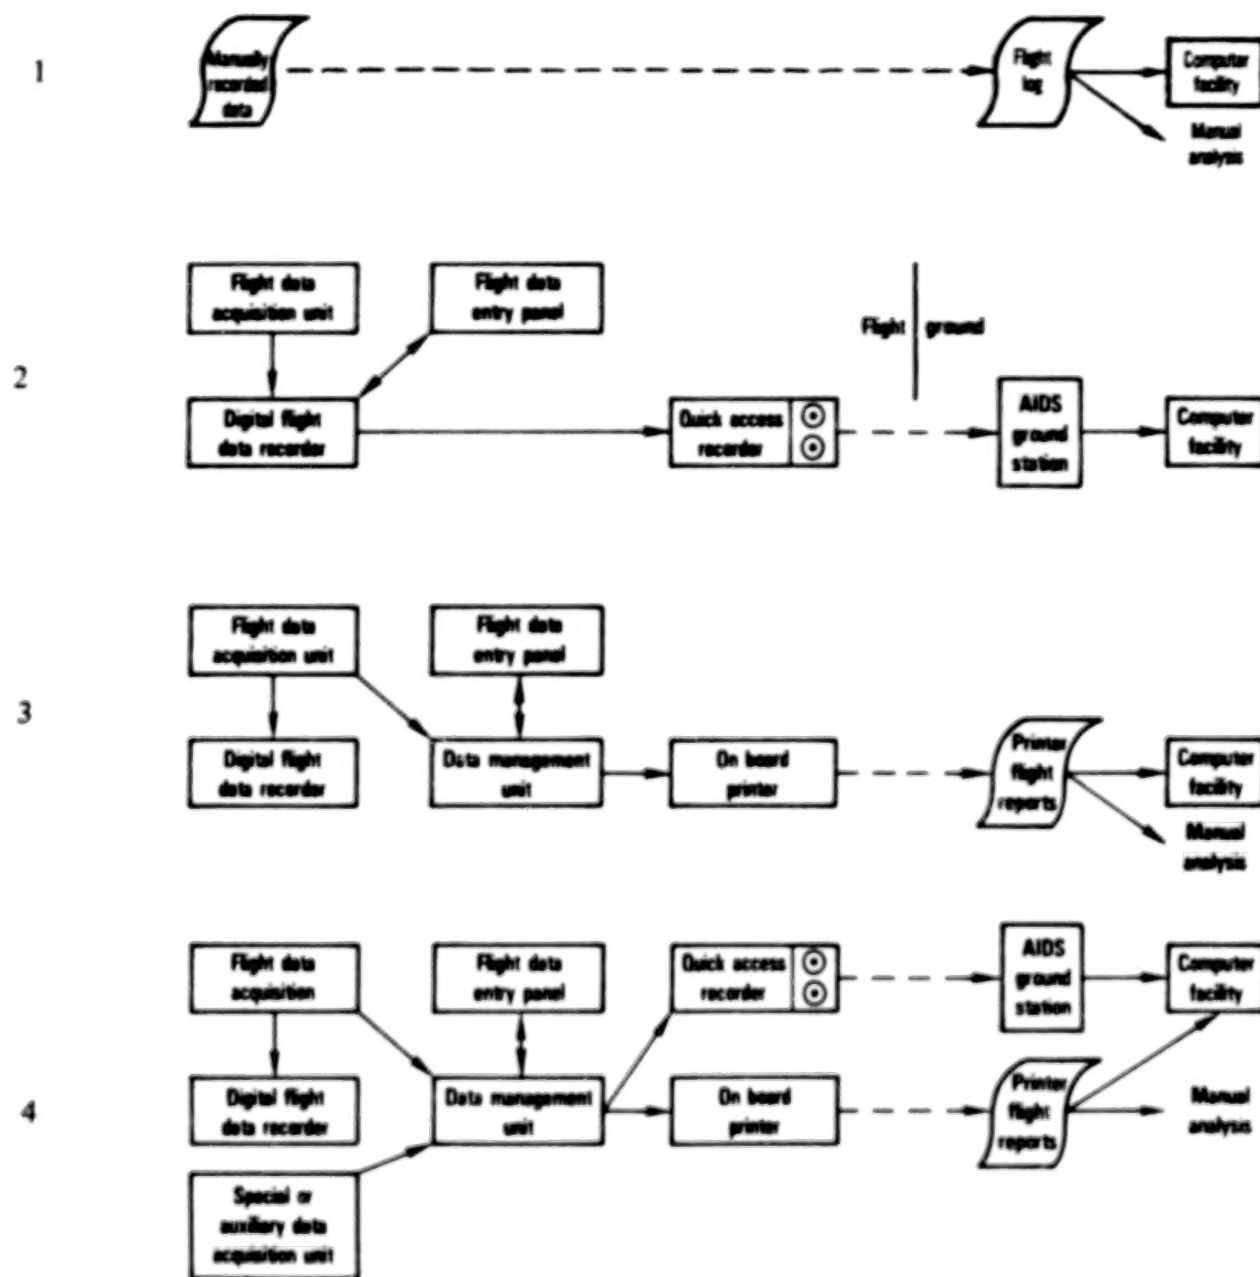
Figure 6 Various Data Acquisition Systems
